# **Screw insertion in trabecular bone causes peri-implant bone damage**

Juri A. Steiner<sup>1</sup>, Stephen J. Ferguson<sup>1</sup>, G. Harry van Lenthe<sup>1,2</sup>

<sup>1</sup>Institute for Biomechanics, ETH Zurich, Vladimir-Prelog-Weg 3, 8093 Zurich, Switzerland

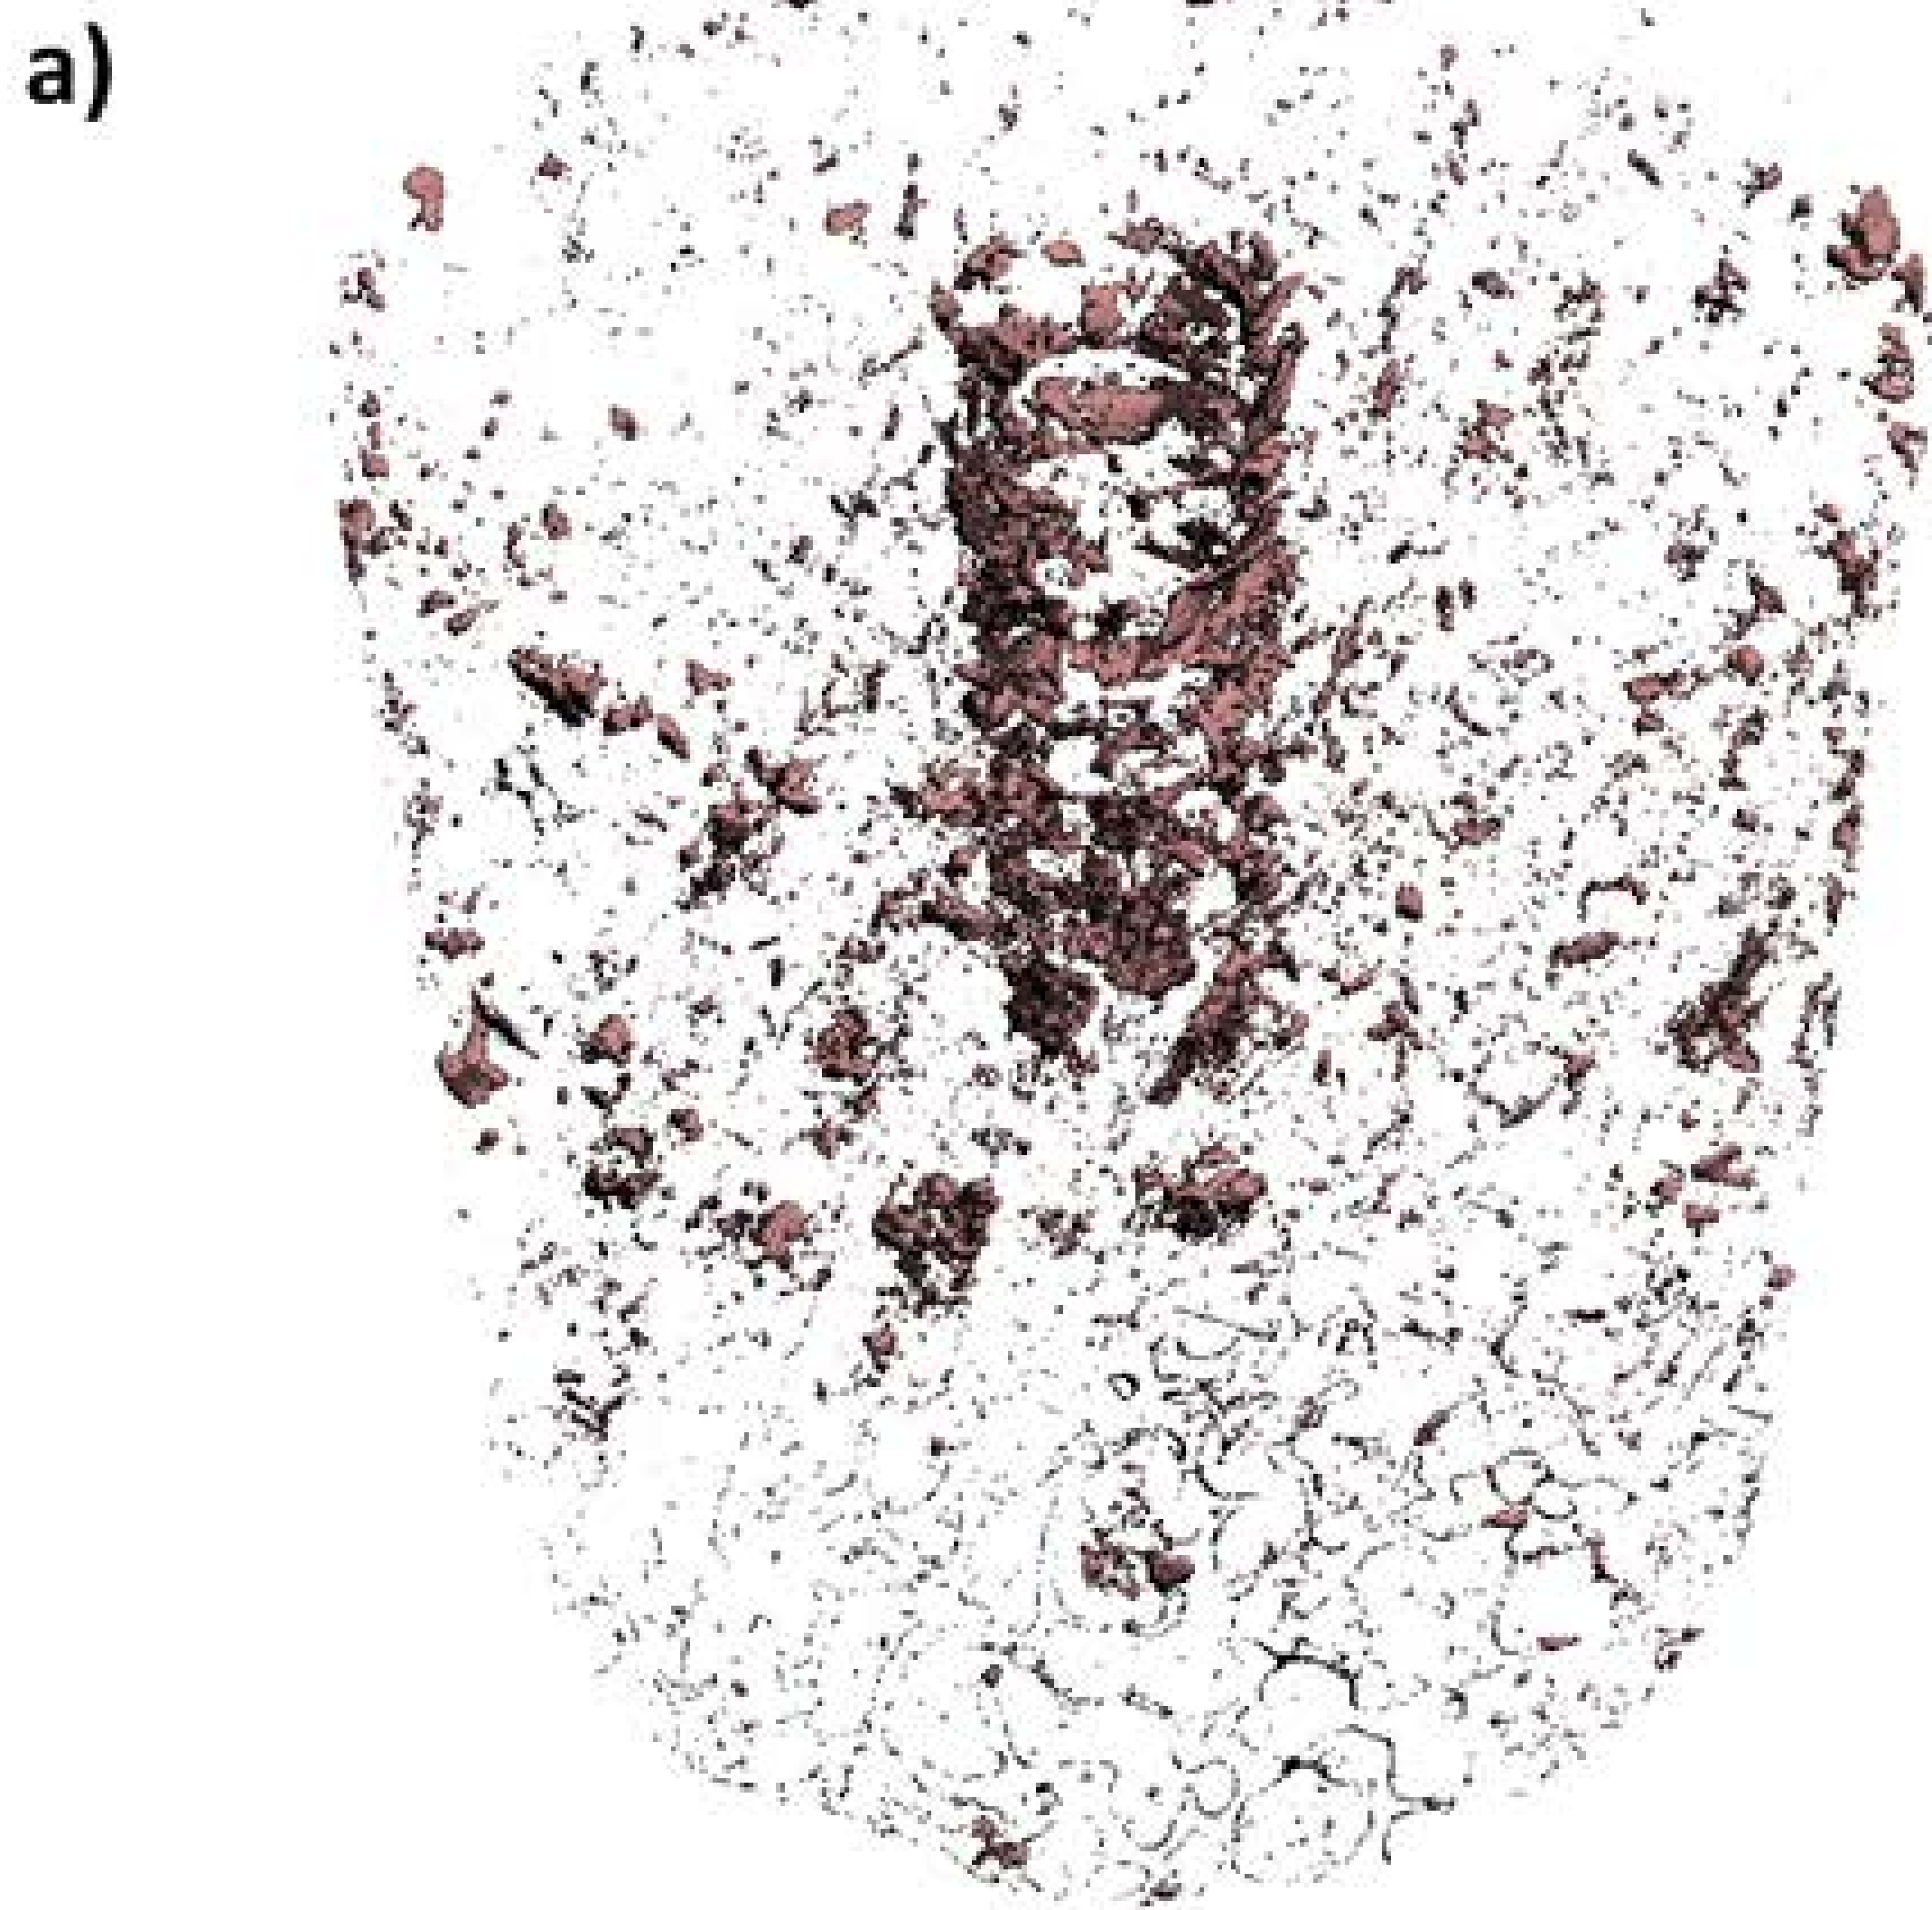
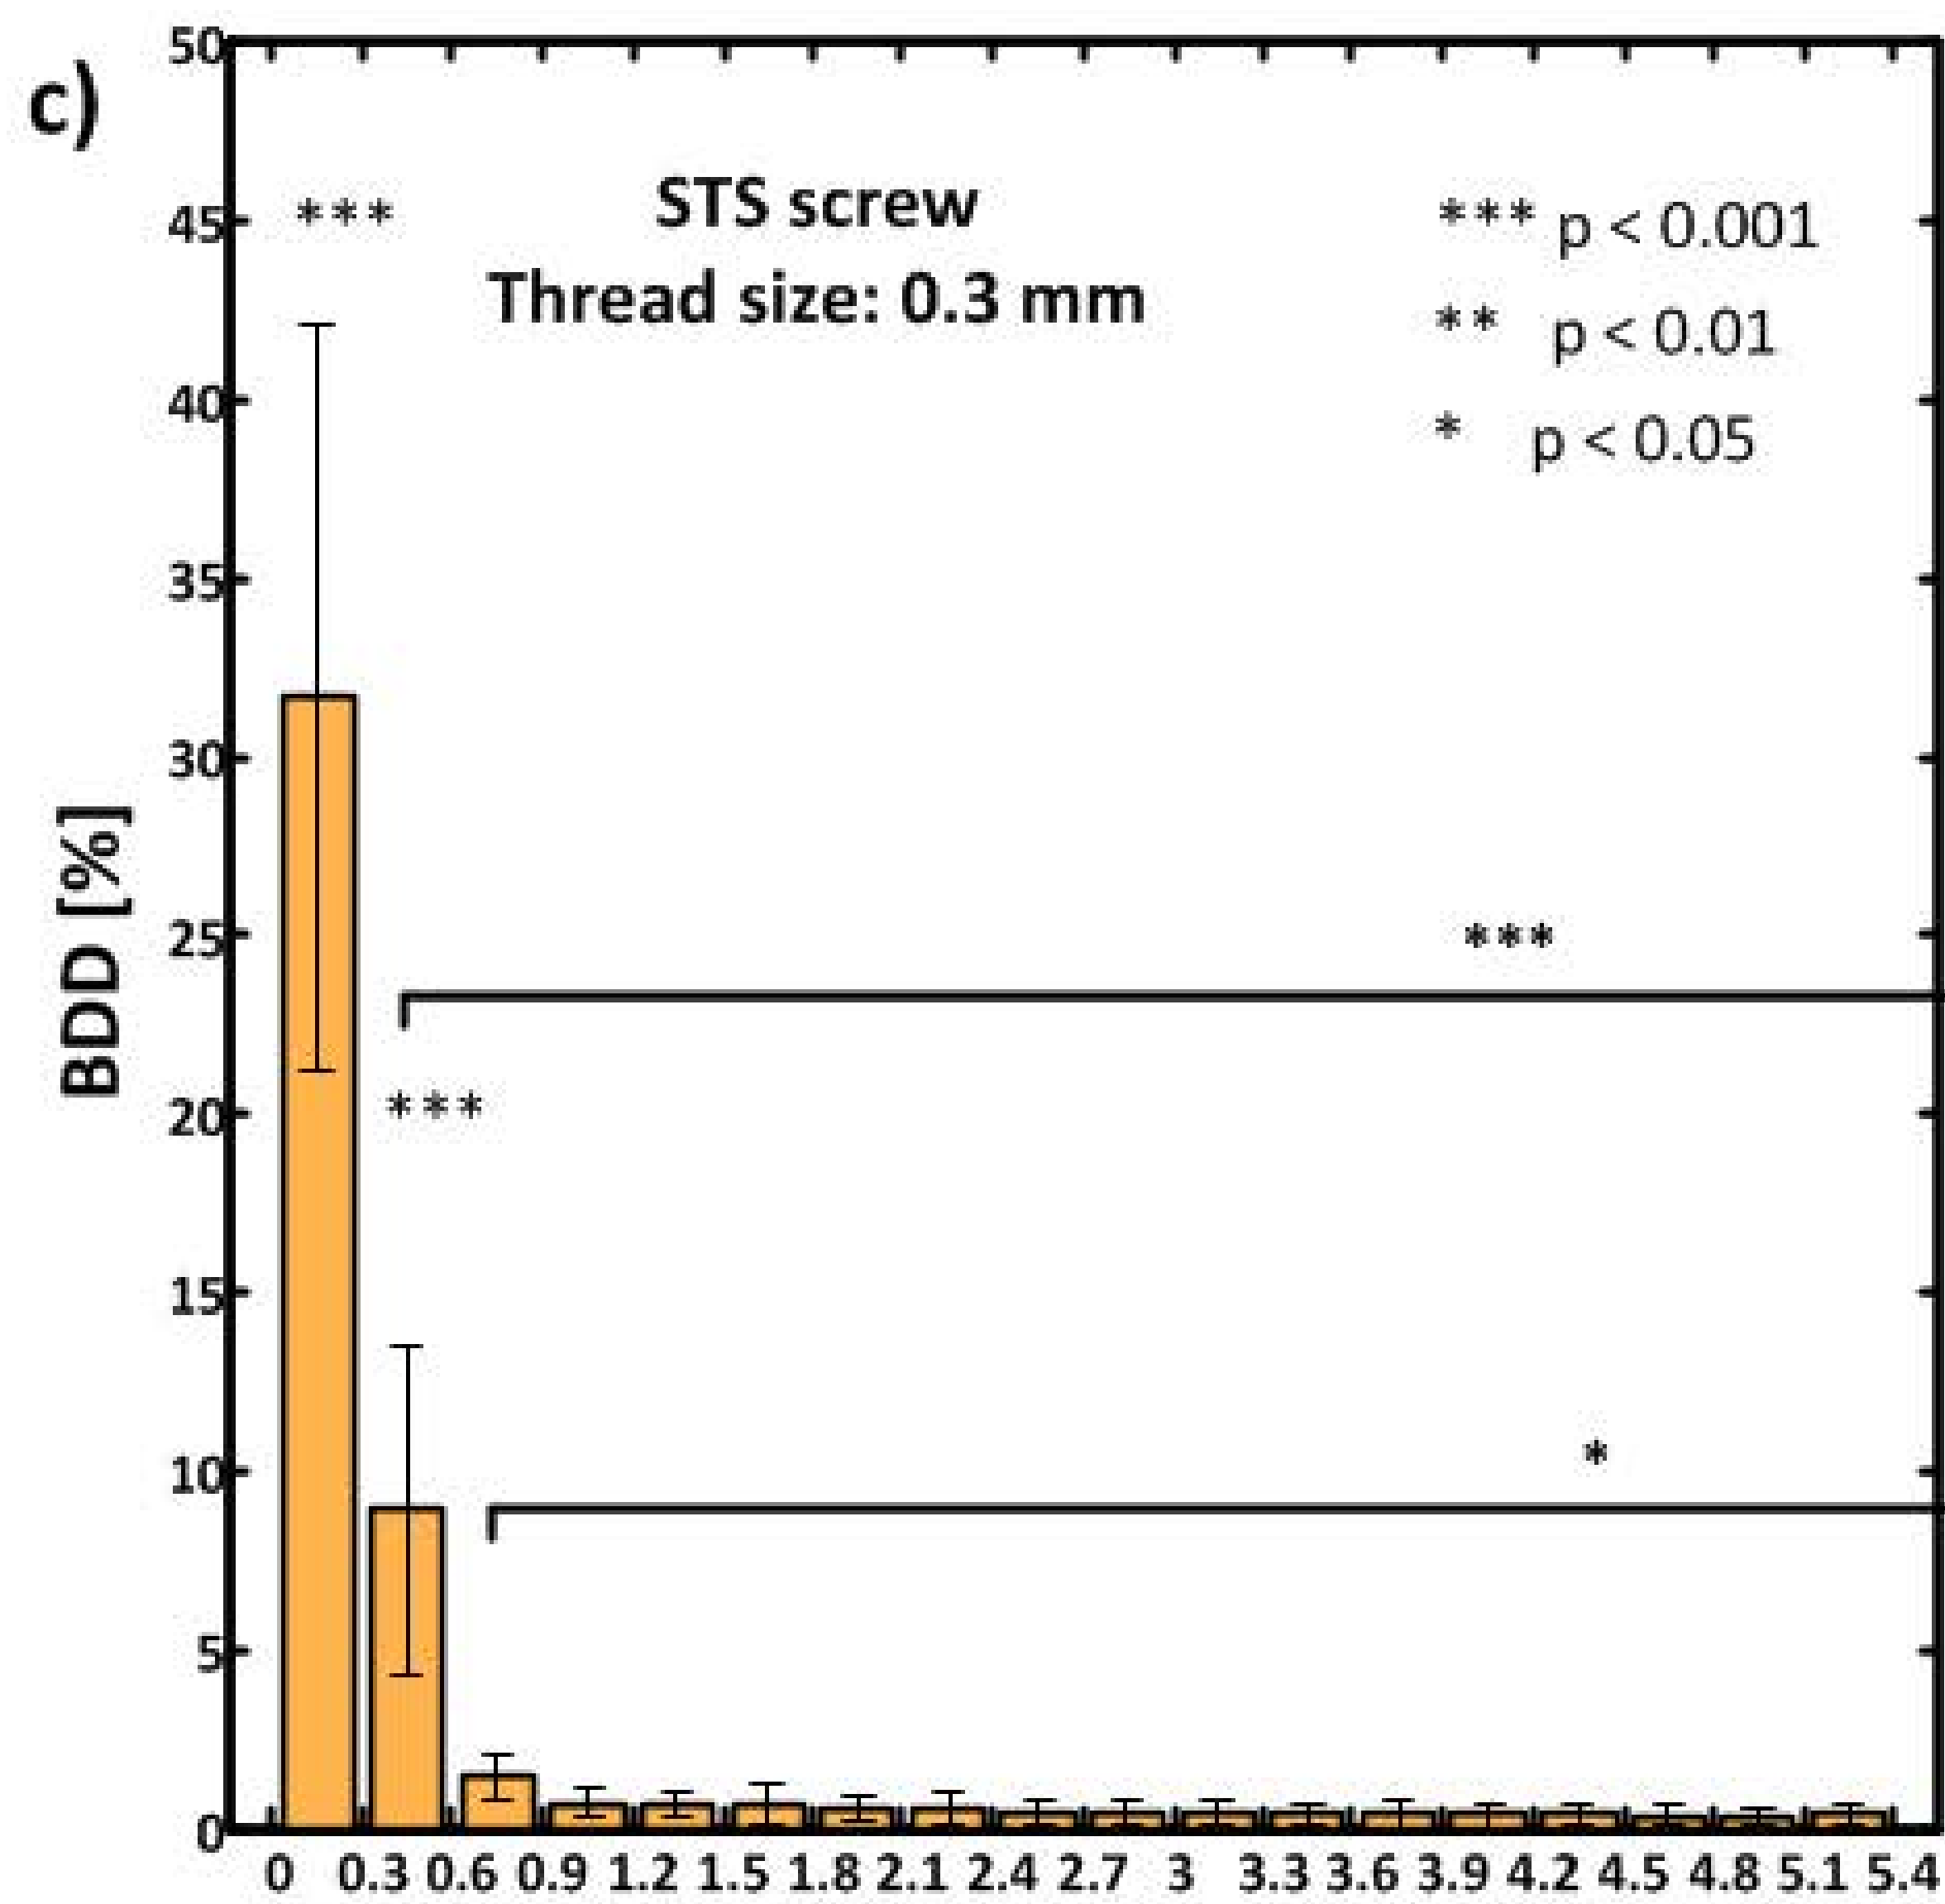
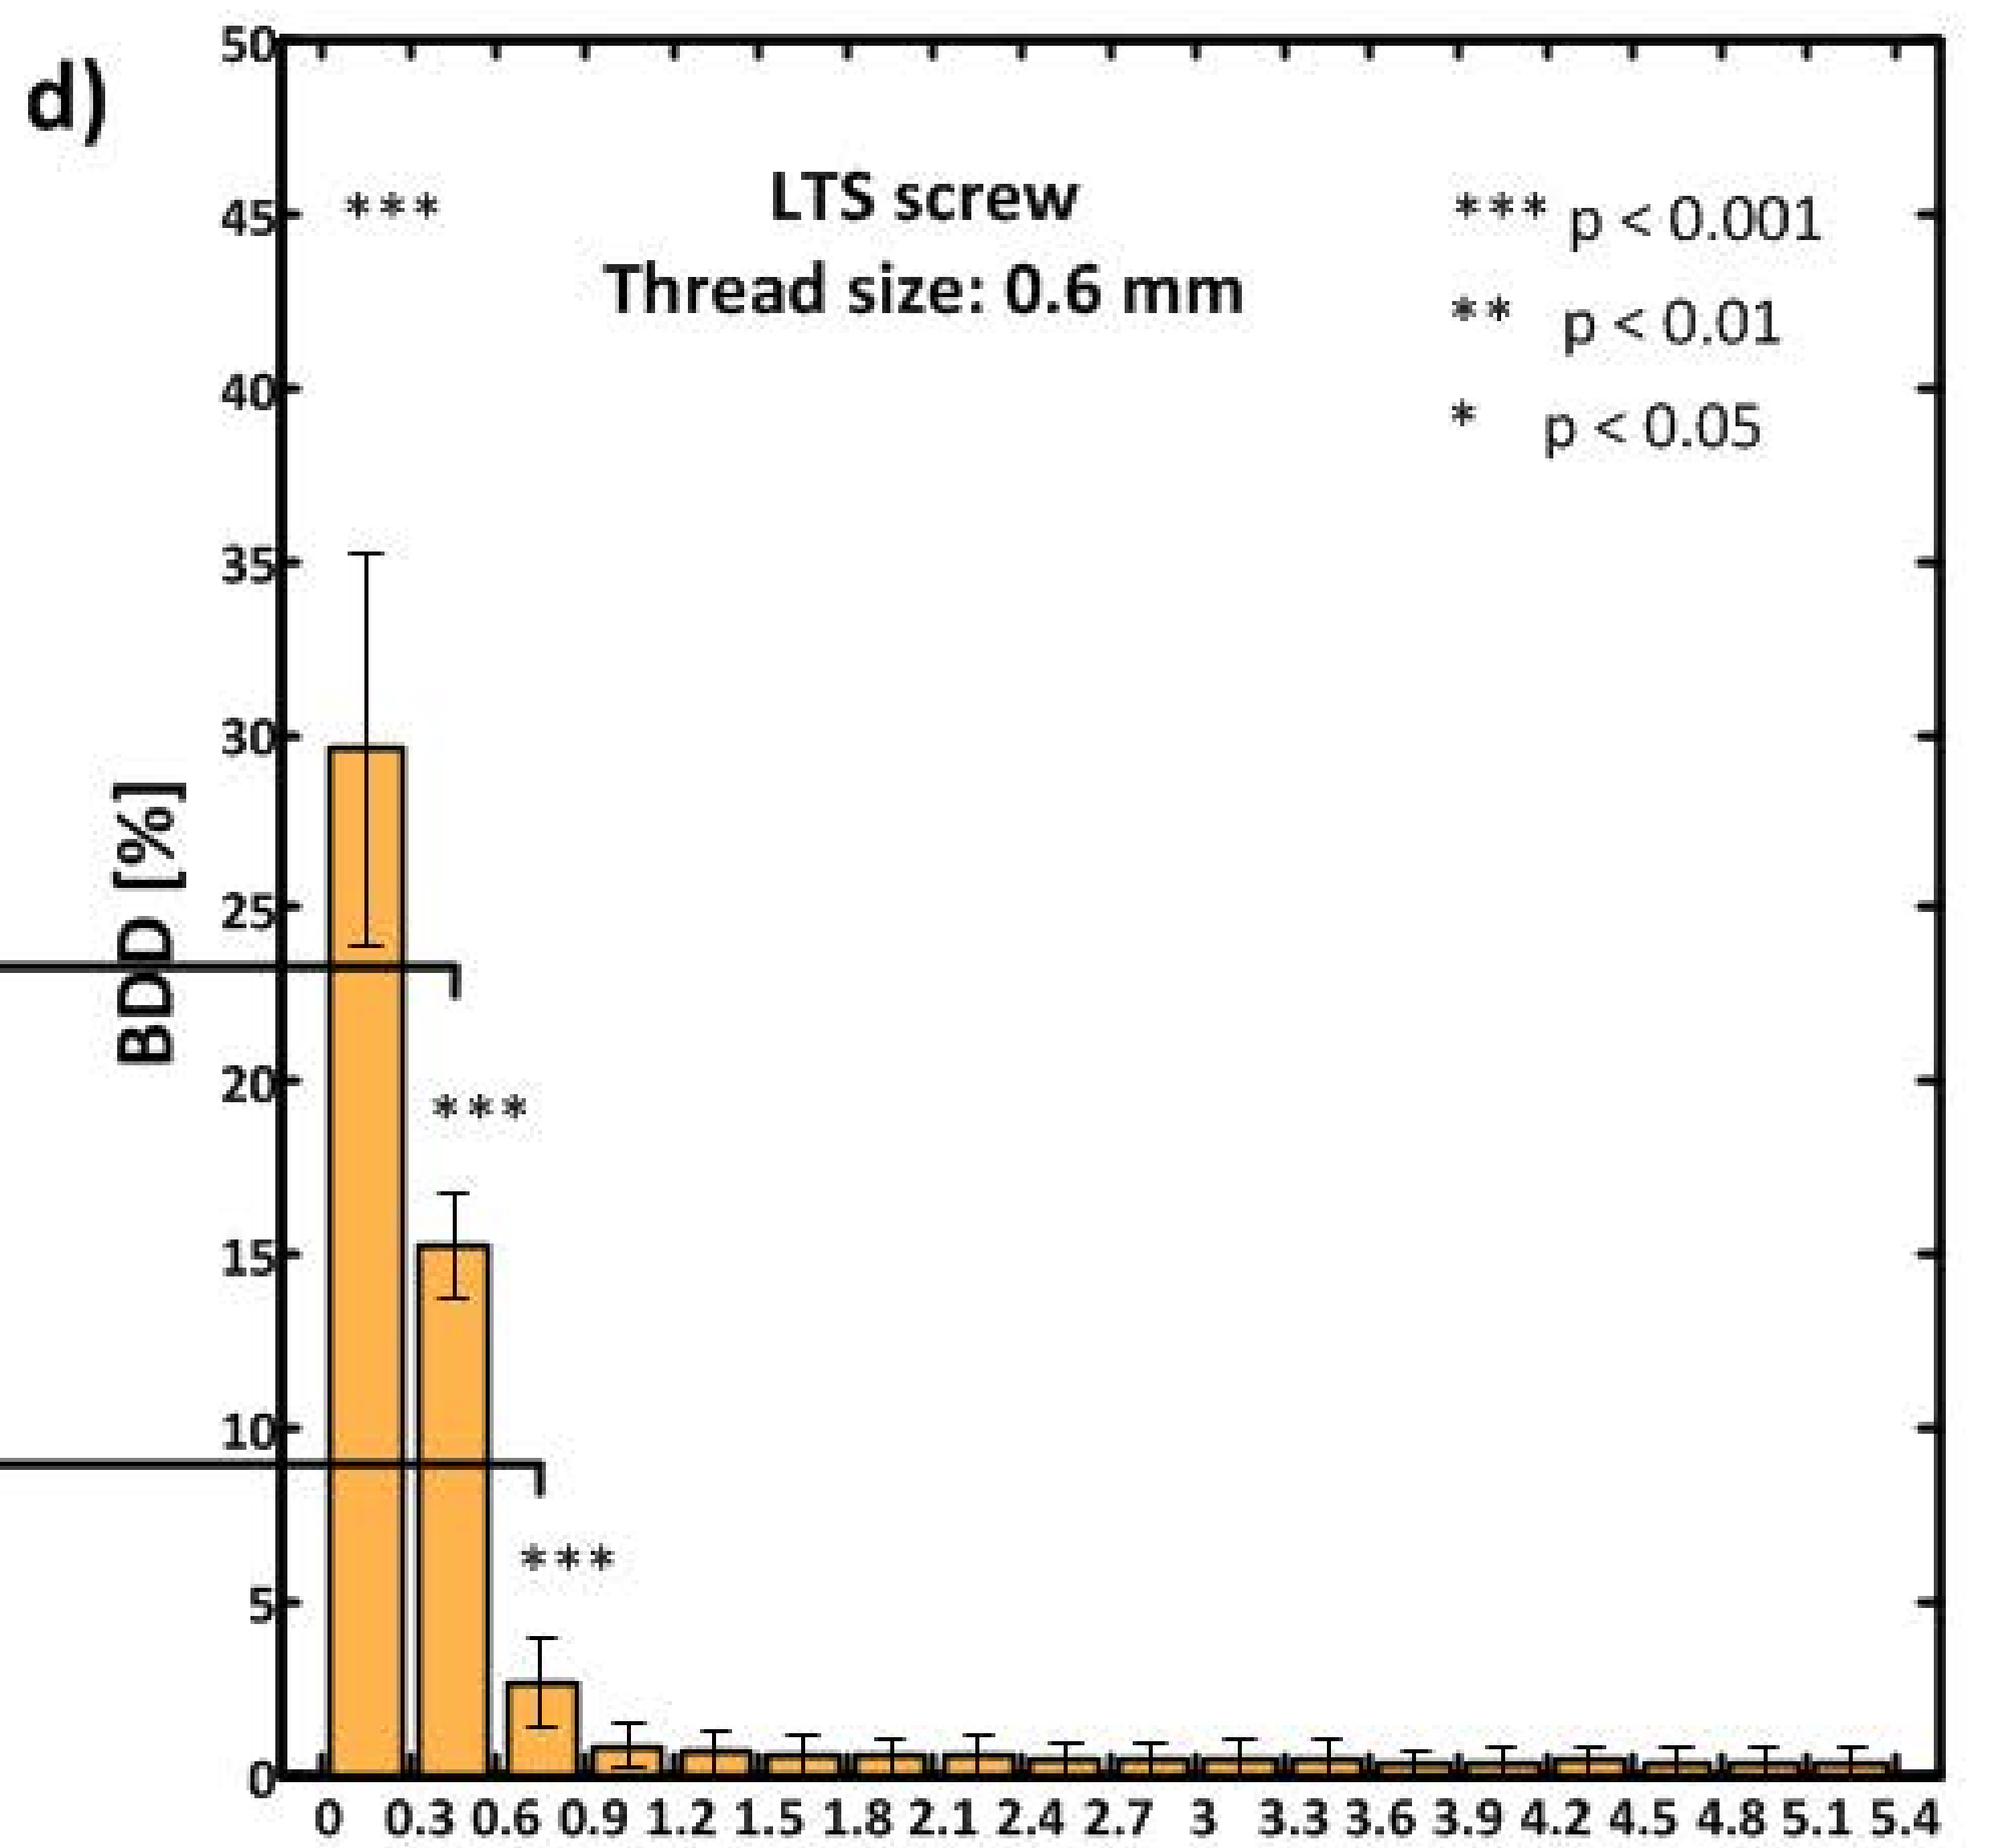
Fig. 5: Bone damage of a representative specimen visualized (a) with a side view of the entire bone core and (b) with a virtual mid-section cut along the axial orientation of the screw. The screw was removed to get a clear view on bone damage throughout the entire specimen. Bone damage densities as a function of the radial distance small thread size (STS) screw (c) and large thread size (LTS) screw (d), respectively. Bone damage density was defined as the bone damage volume normalized to bone volume.

A visual comparison between the PI and DI model showed clear evidence for peri-implant bone damage due to screw insertion (indicated by red arrows in Fig. 2). Further visual assessment of the computed bone damage revealed a clear densification of BDD towards the implant site (Fig. 5a and 5b). For the STS group, BDD was significantly higher than the precision up to 0.6 mm distance from the screw (Fig. 5c). For the LTS group significant differences were found up to 0.9 mm radial distance from the implant (Fig. 5d). In both groups, we could observe that with increasing distance from the screw, BDD quickly converged towards the precision level (Fig. 5c and 5d). The LTS group showed significantly higher BDD values than the STS group in the VOIs between 0.3-0.6 and 0.6-0.9 mm distance from the implant. Highest BDD values were found in the VOI closest to the implant; no significant differences in BDD were found between the STS and LTS groups. The average BV/TV over all specimens is  $27.2\% \pm 4.1\%$ . BV/TV for the STS and LTS group was  $25.8 \pm 1.9\%$  and  $29.0 \pm 4.6\%$ , respectively ( $p=0.064$ ). Within the VOIs where BDD was significantly higher than the precision, BV/TV shows no significant correlation to BDD in both groups ( $R^2 < 0.4$  and  $p > 0.05$ ).
